SCIENTIFIC ELECTRONIC PRODUCTS, INC.
FINAL REPORT
RELIABILITY STUDY OF HC-27/U HOLDER
CONTRACT NO. DA-36-039-SC-87456
TASK NO. 3A-99-15-007-01
PLACED BY U. S. ARMY
SIGNAL RESEARCH & DEVELOPMENT LABORATORY
FORT MONMOUTH, NEW JERSEY

RELIABILITY STUDY
OF
HOLDER HC-27/U

FINAL REPORT

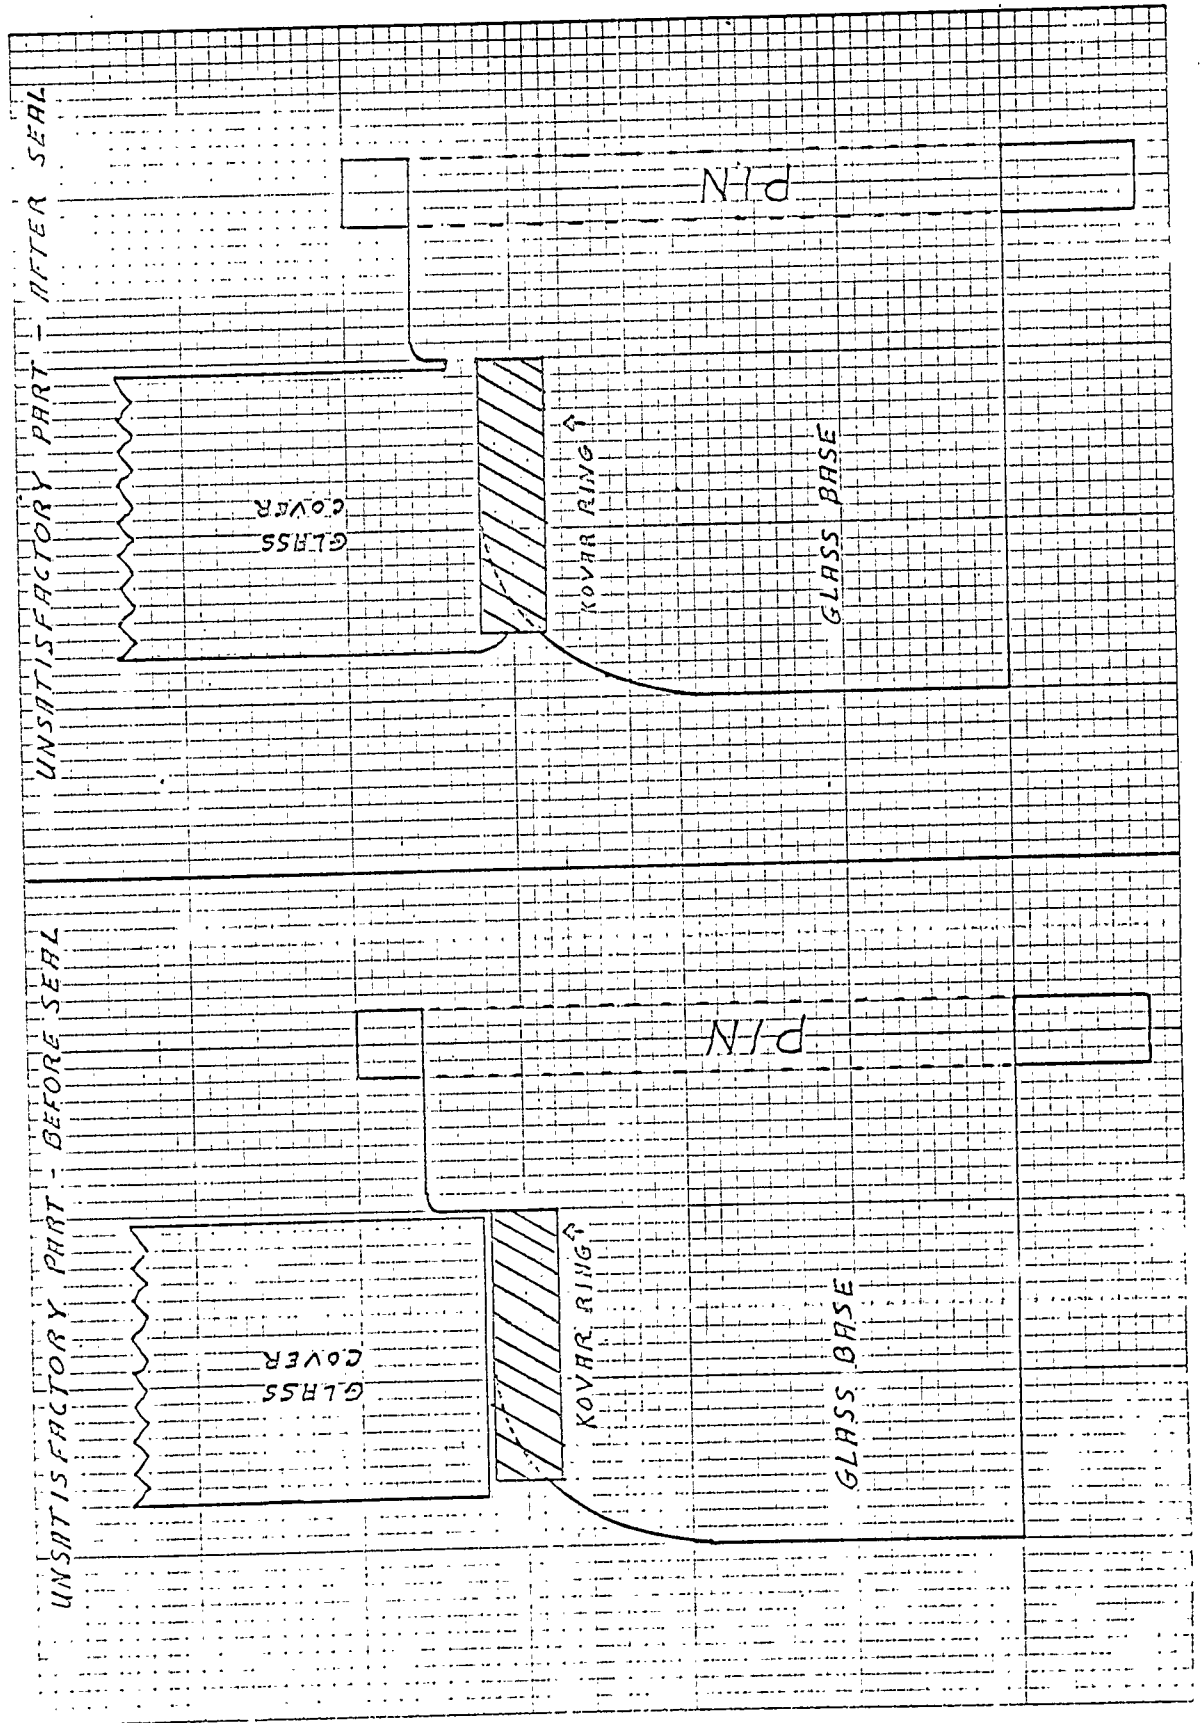
Fig. 9

The parts from both sources were defective in many respects. The covers were not of uniform size and shape, the wall thickness varied greatly and the edges were in many cases, uneven, chipped and cracked. The bases were likewise, non-uniform in size and shape and thickness varied widely. The amount of glass frit applied over the Kovar ring also varied greatly.

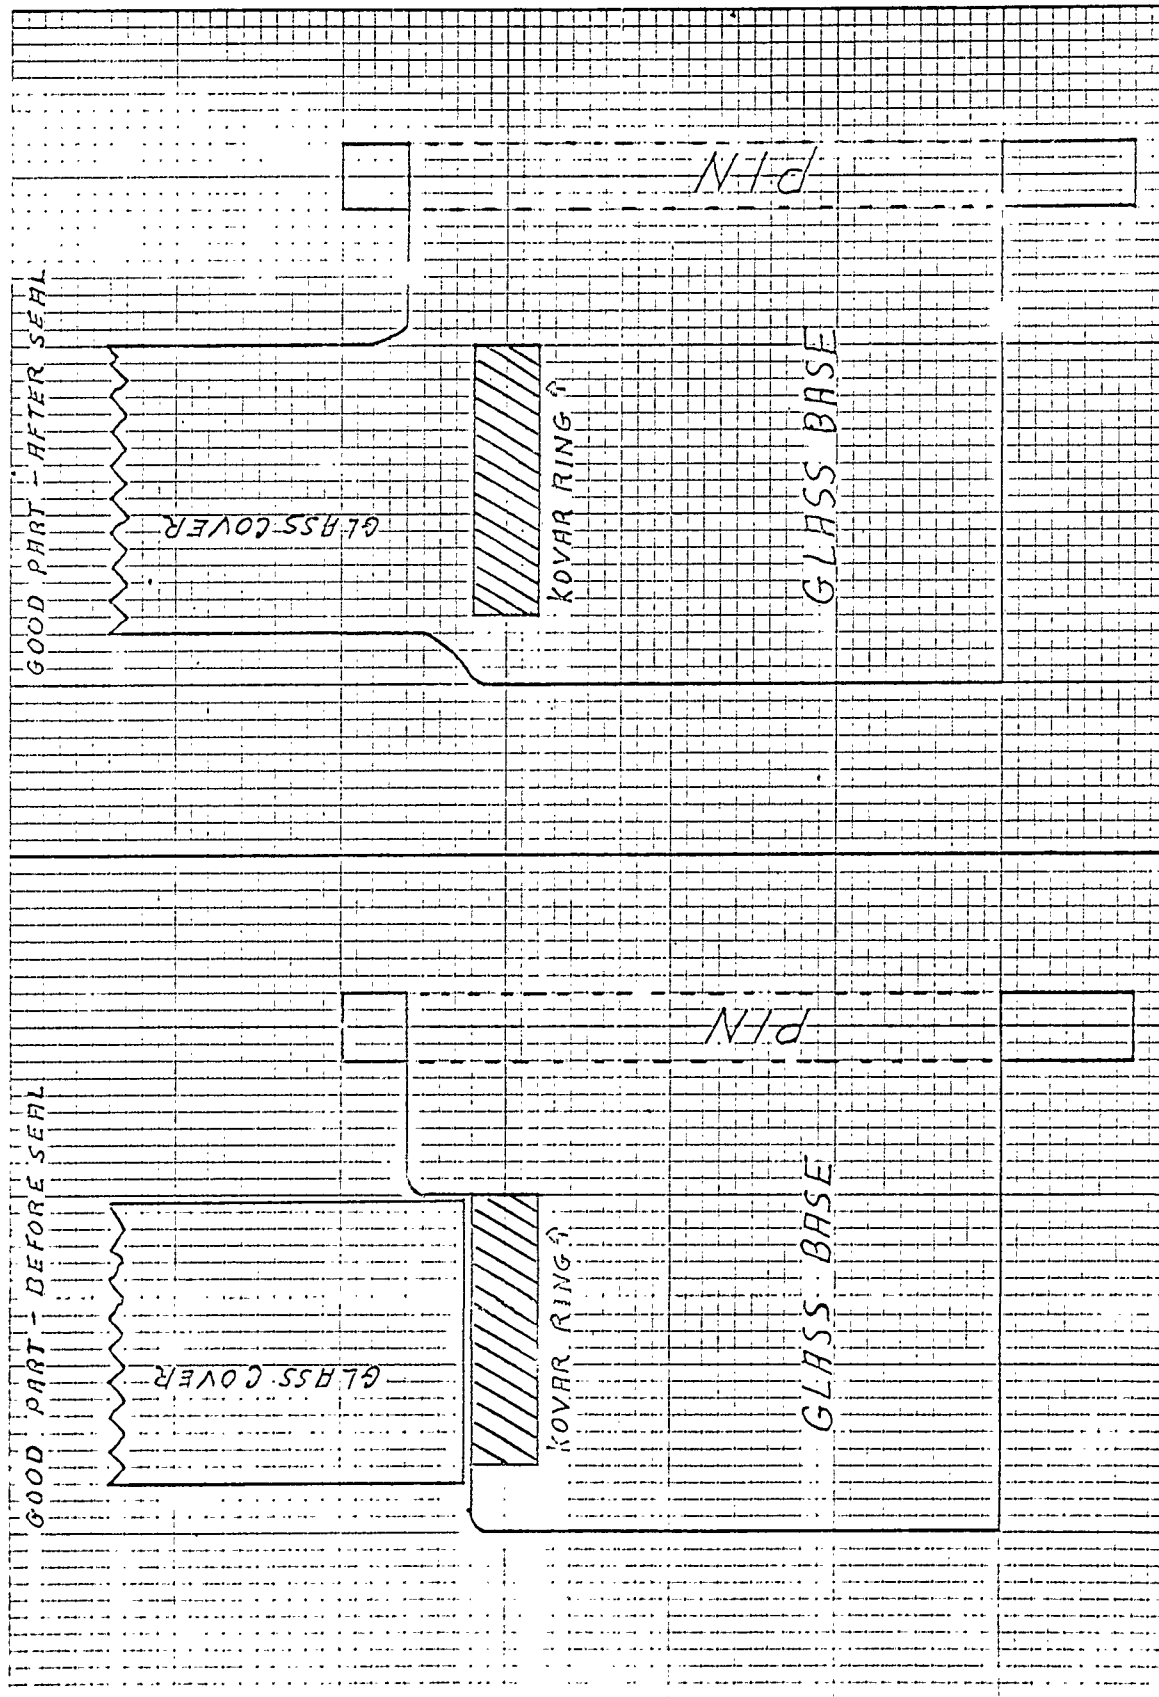
Fig. 10

1. The glass bases should be of uniform thickness and size.
2. The raised land on top of the base should be uniform in height and shape so that it will fit the cover well enough to automatically position the cover when it is placed over the land.
3. The base must have fairly square outside shoulders that show a rim of glass outside the Kovar ring.
